CORPS OF ENGINEERS
NATIONAL DAM INSPECTION PROGRAM
CONNECTICUT RIVER BASIN

LAKE MONOMONAC

MA 00632

DELETED FROM PROGRAM
(LOW HAZARD POTENTIAL)

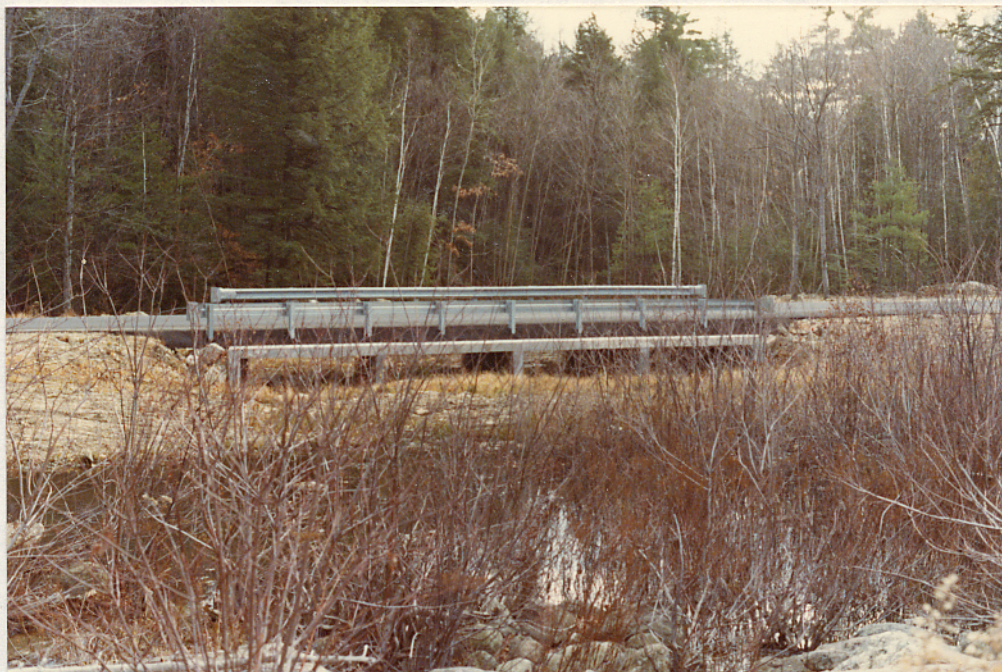
Downstream bridge and culvert viewed
from spillway crest.

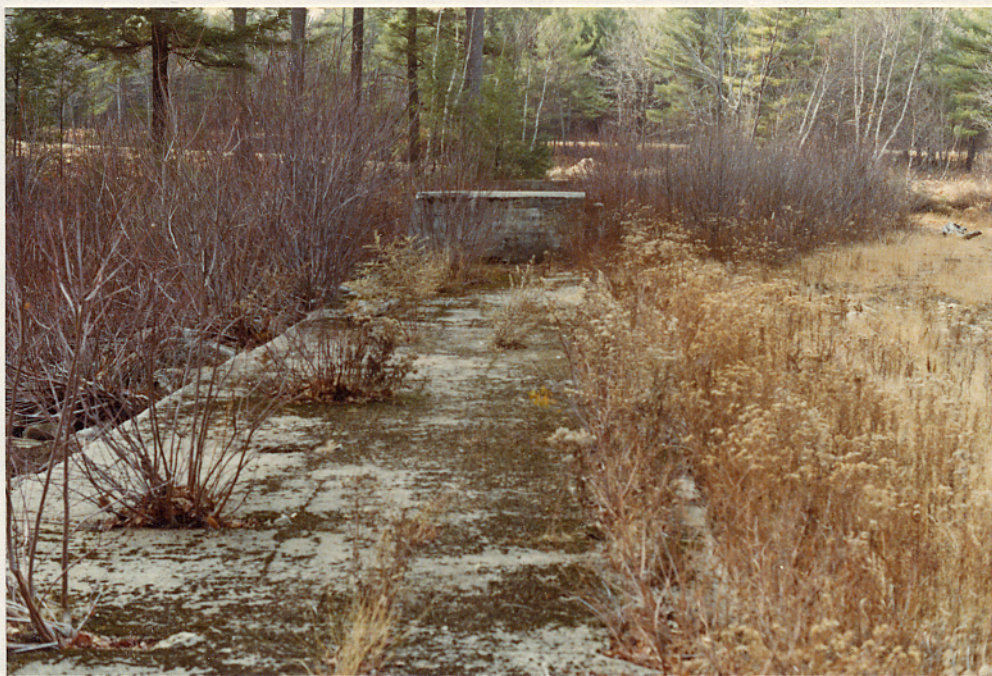
Spillway crest viewed from left abutment.

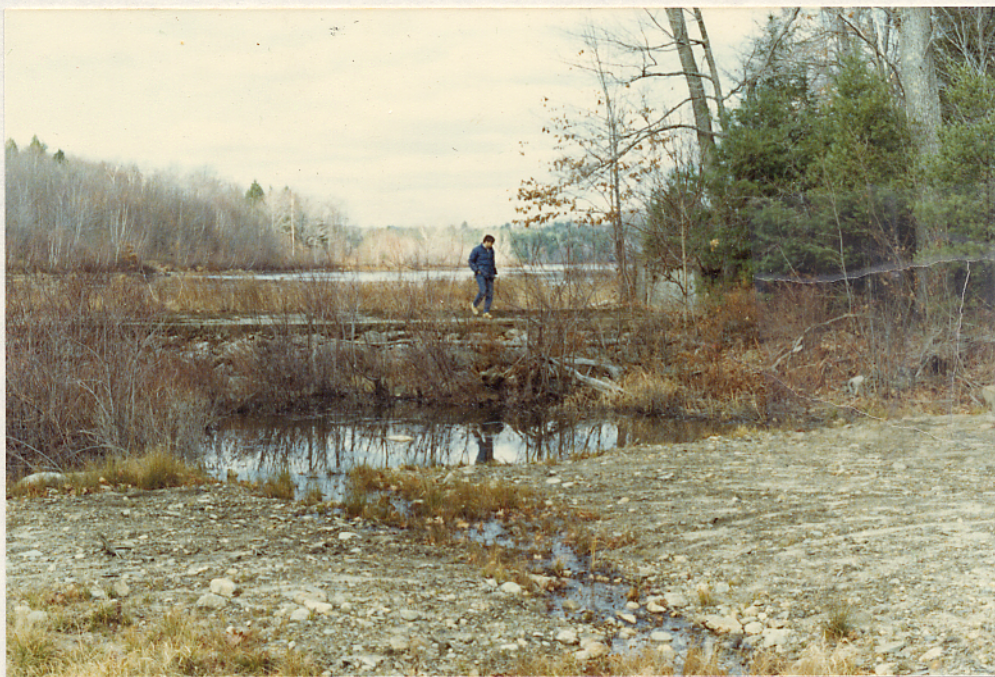
Downstream view of spillway viewed
from downstream bridge.
